• PROTECTING INLAND LAKES THROUGH NATURAL SHORELINES

An Introductory Guide to Bioengineering Techniques

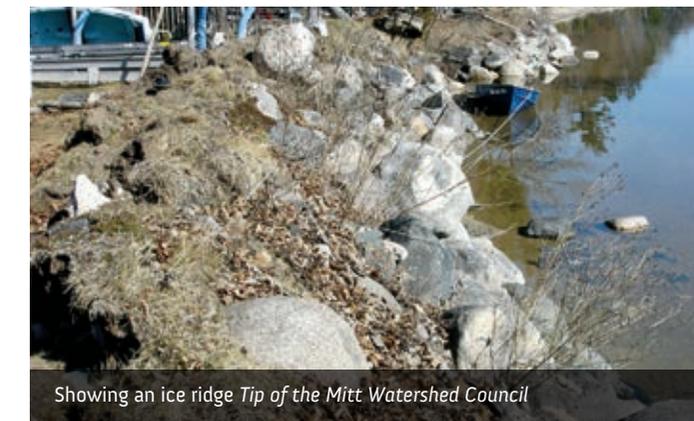
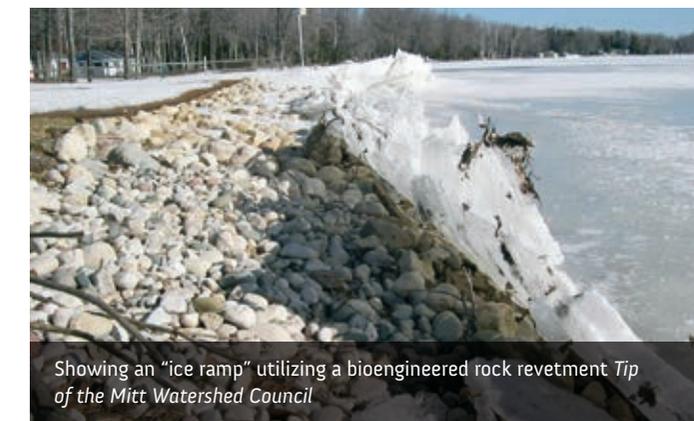
DEPICTION OF ICE STRENGTH

Figures 2A and 2B: Showing ice push and break up along a shoreline.

- Ice is the strongest as it moves horizontally toward a shoreline. It can exert 10-12 tons per square foot of pressure on our shorelines. (See Figure 2A)
- Ice becomes weaker as it moves at an angle and even weaker over rough surfaces. (See Figure 2B)

Bioengineering techniques can be used to help weaken ice push through the use of rock and vegetation to provide varying roughness options. The rock must be sized, placed, and sloped correctly in order to provide an appropriate angle and roughness. Vegetation should be native plants, including trees and shrubs, to provide the root structure.

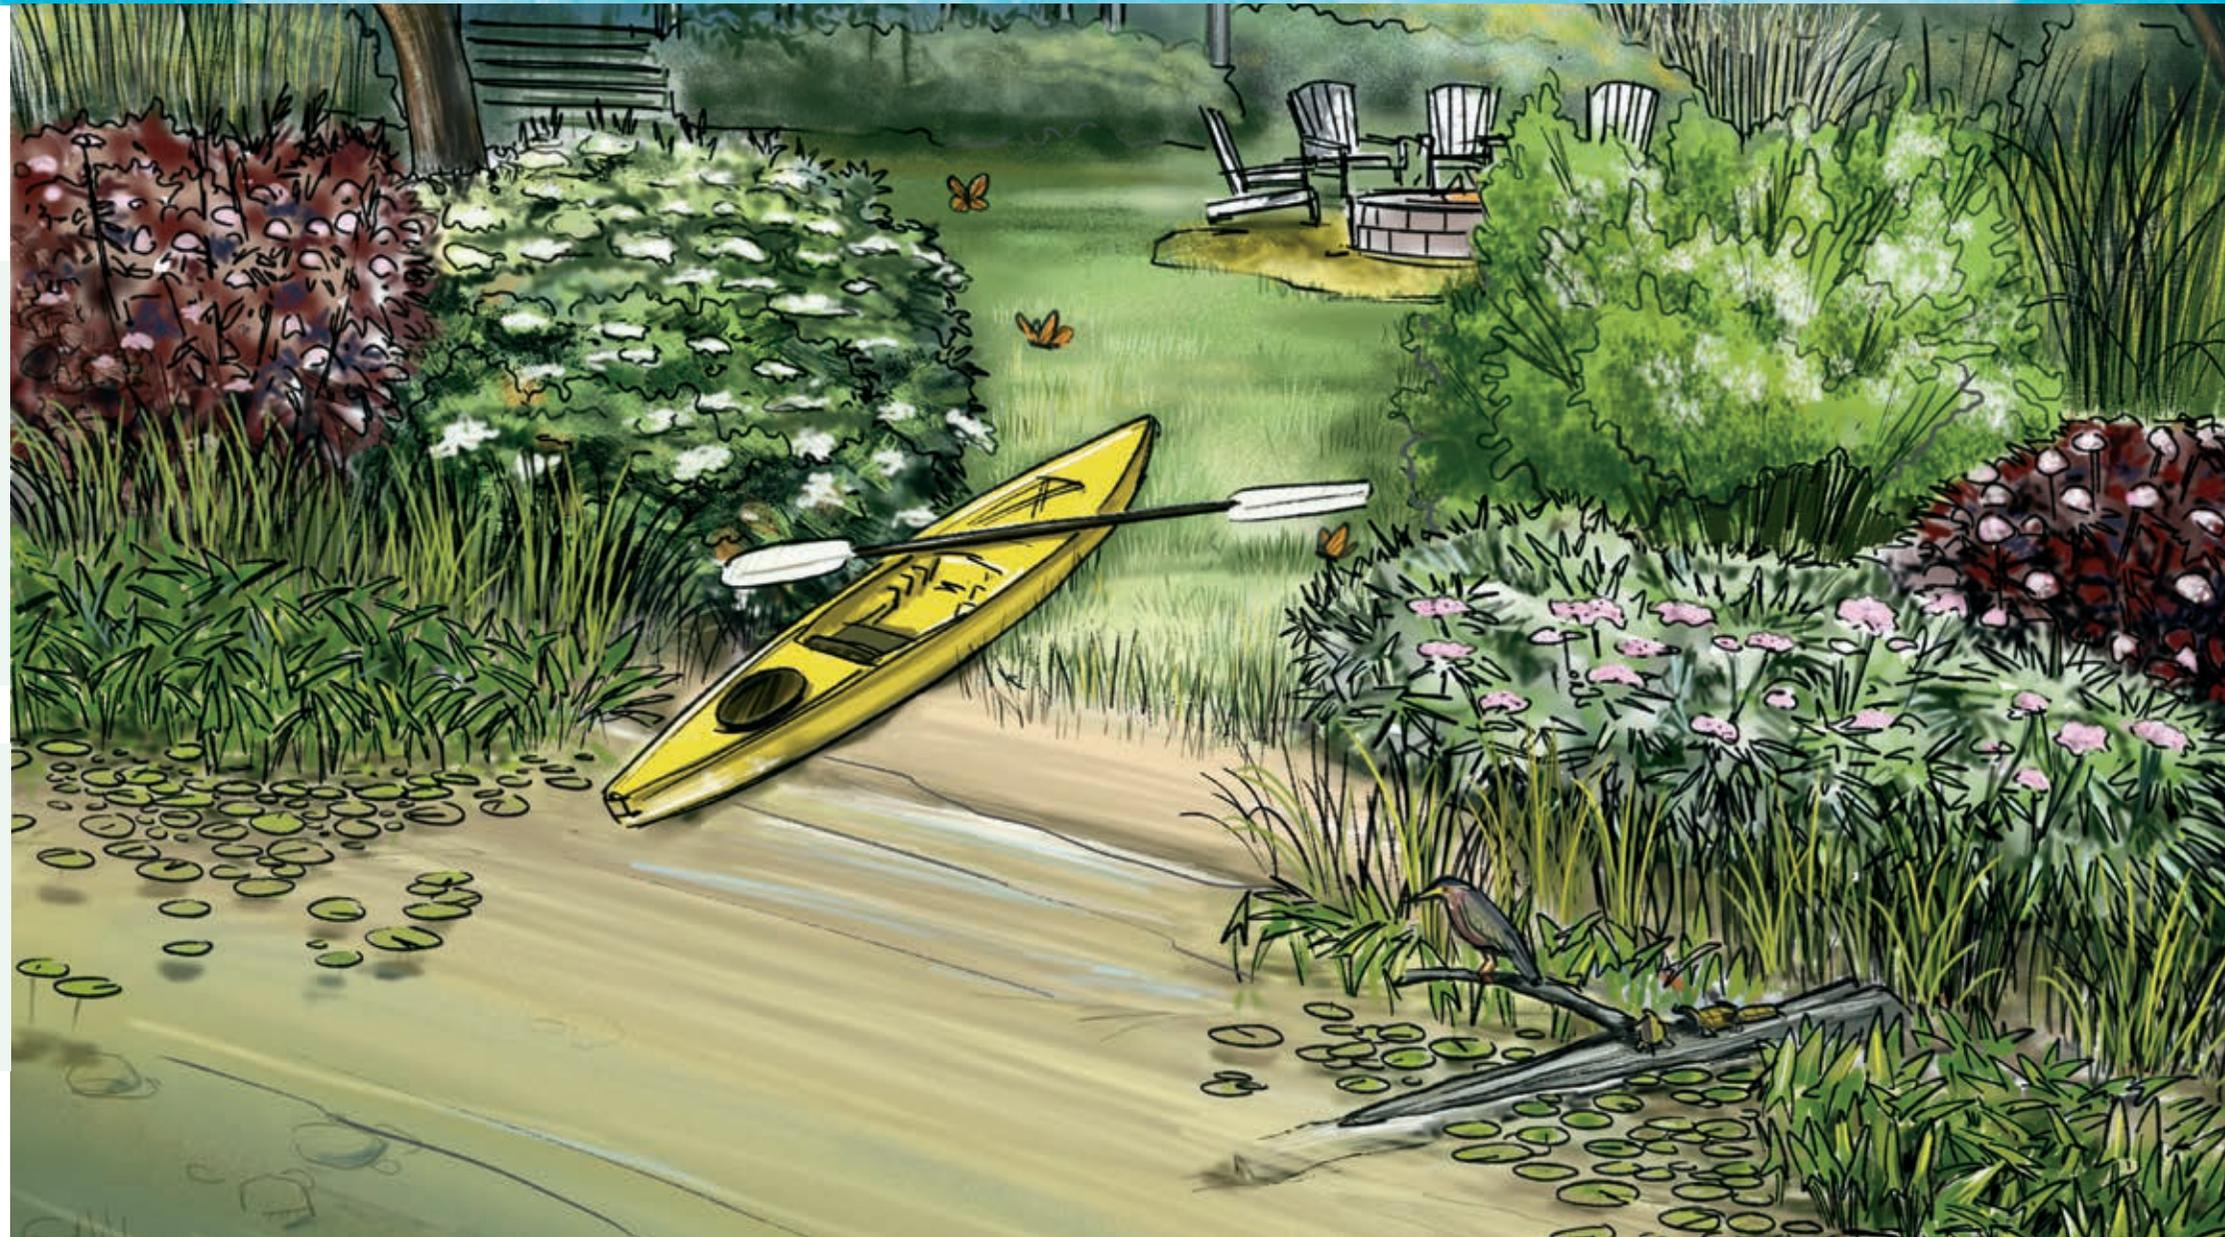
Figure 3: A shoreline balancing recreational access with shoreline habitat and lake health.

Keeping native vegetation both on the land and in the water provides habitat for fish and wildlife. It is also critical for helping to prevent shoreline erosion. (Figure 3)

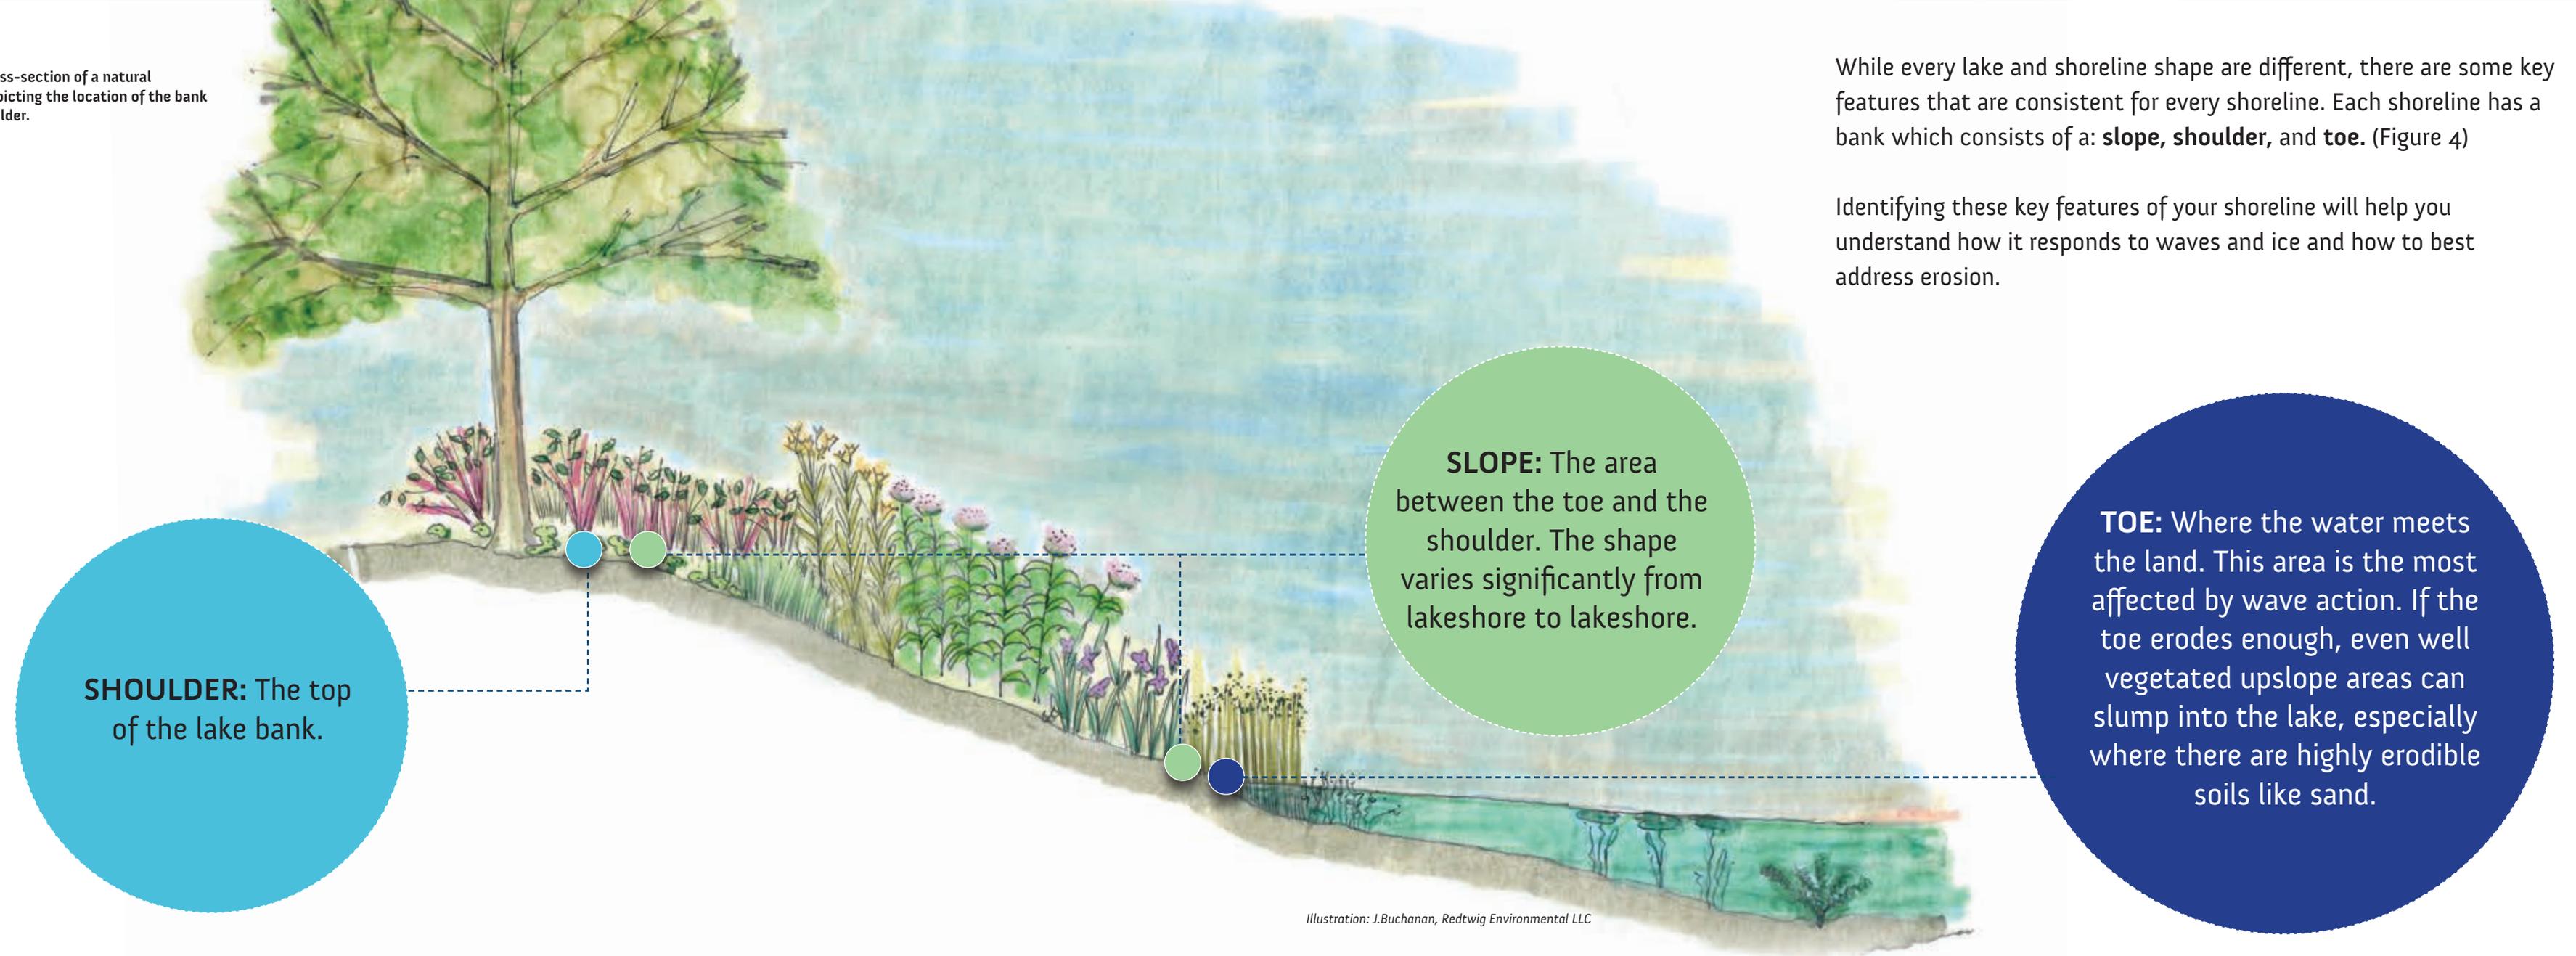
Figure 4: Cross-section of a natural shoreline depicting the location of the bank toe and shoulder.

While every lake and shoreline shape are different, there are some key features that are consistent for every shoreline. Each shoreline has a bank which consists of a: **slope, shoulder, and toe.** (Figure 4)

SHOULDER: The top of the lake bank.

SLOPE: The area between the toe and the shoulder. The shape varies significantly from lakeshore to lakeshore.

TOE: Where the water meets the land. This area is the most affected by wave action. If the toe erodes enough, even well vegetated upslope areas can slump into the lake, especially where there are highly erodible soils like sand.

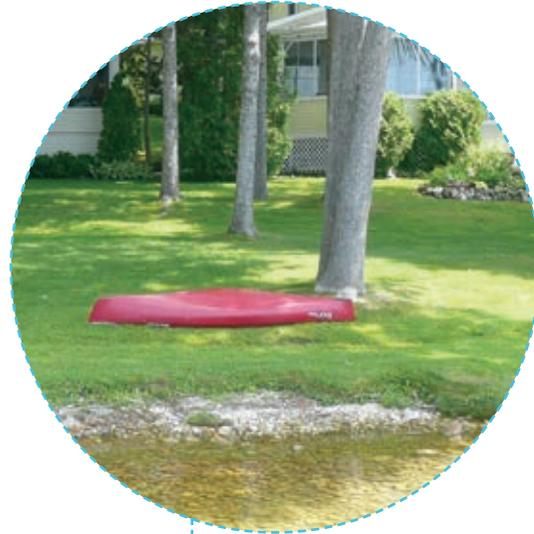
Receding Shoreline:
Shoreline is advancing landward over time.

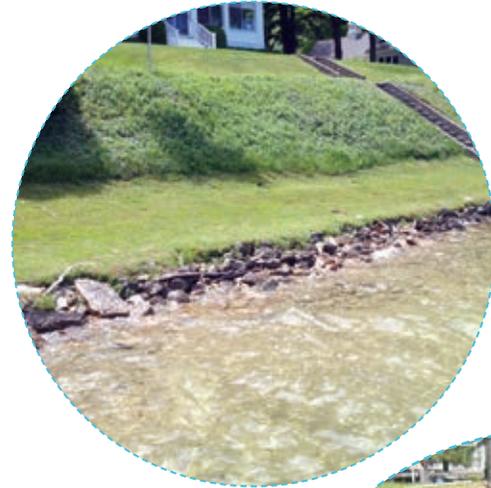
Receding shoreline:
Example where the addition of rock is ineffective due to improper design and lack of shoreline vegetation.

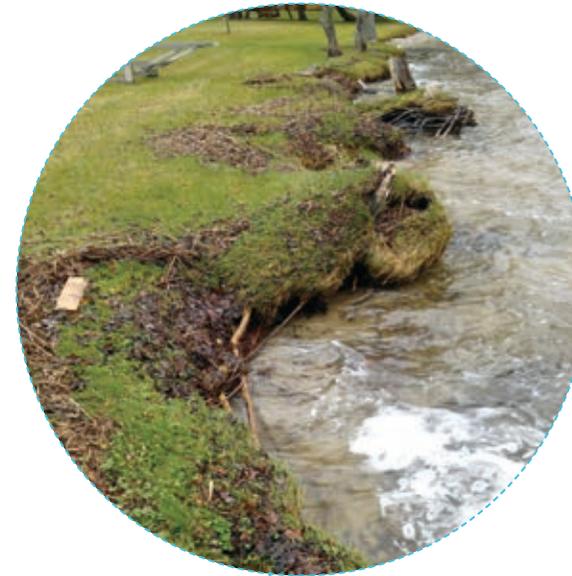
Scalloping:
The irregularities of the shoreline become more pronounced due to exposed shoreline soils. Eventually, the "points" will also erode as residual root structure from the removed vegetation degrades.

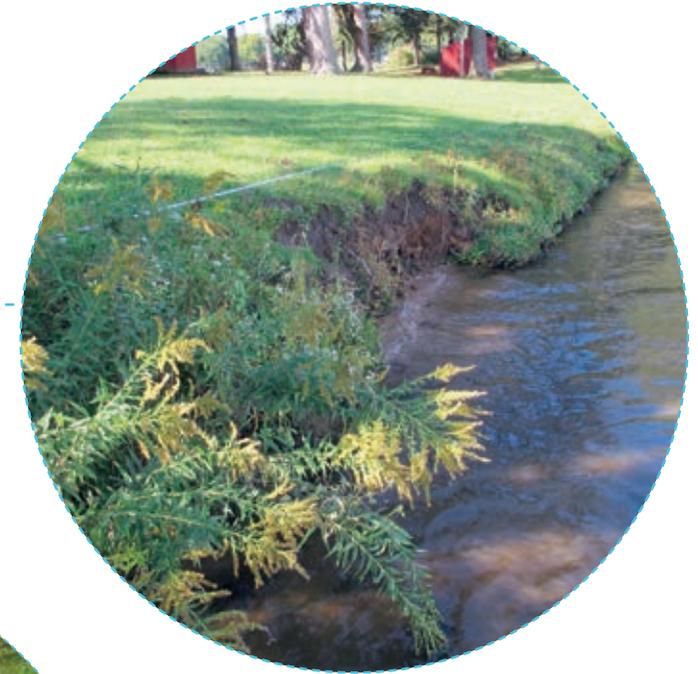
Root Exposure:
It is natural to have some roots exposed along shorelines, however, pronounced root exposure is a sign of accelerated erosion.

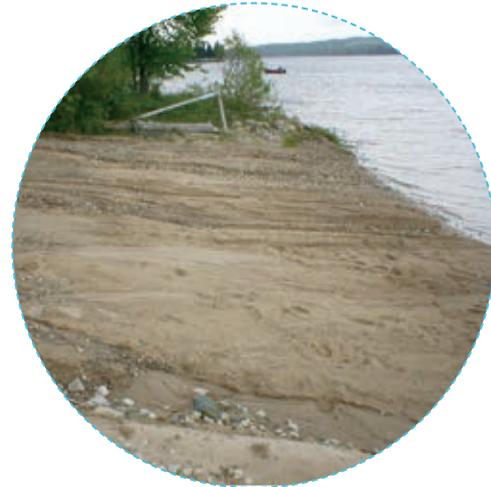
Rills and Gullies:
Channels form from overland runoff due to exposed soil.

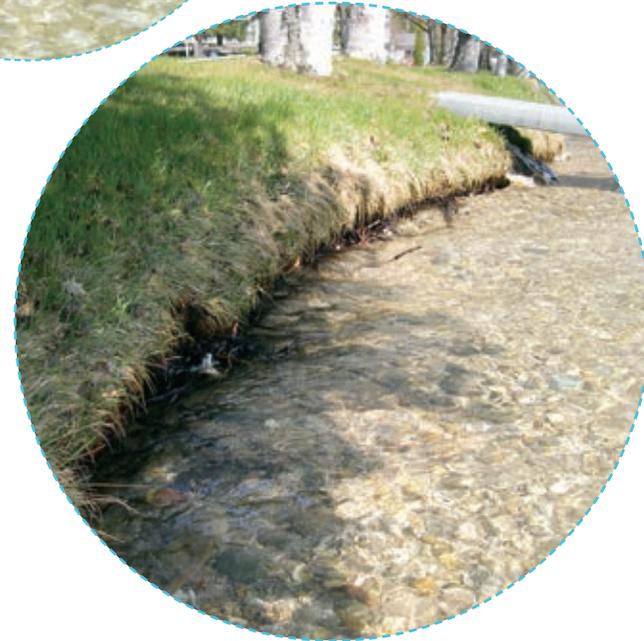
Undercut Bank:
Waves are eroding the soil underneath the bank. Eventually the bank will slump into the lake.

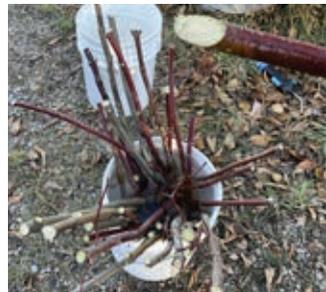
Live Stakes
Photo: J. Kirkwood

Native vegetation is essential for every bioengineered project. It provides the necessary root structure to hold the shoreline soils in place. A mixture of flowers, grasses, sedges, shrubs, and trees should be used. Depending on the site, either plugs, larger stock, pre-vegetated mats, live stakes or a combination of plant stock types should be used. Live stakes, are cuttings from woody shrubs, such as willow and ninebark, that can root and grow. Seed should only be used in limited situations such as large scale restoration projects.

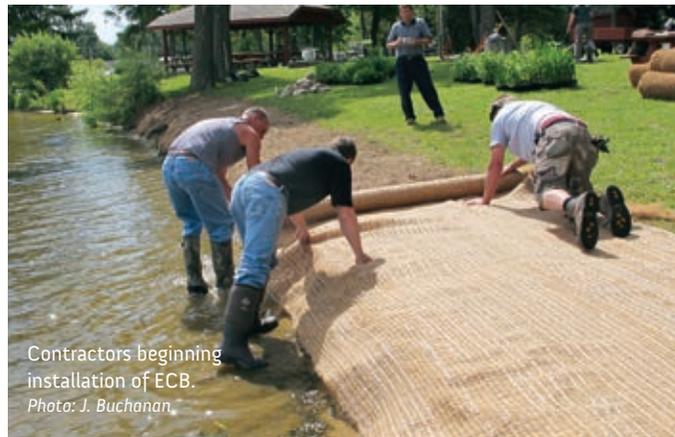
Contractors beginning installation of ECB.
Photo: J. Buchanan

Biodegradable erosion control blankets (ECBs) are used to help stabilize shoreline erosion. ECBs should extend landward the distance needed to cover all exposed soils. Ideally, they should also extend the full depth of the planting area to help with weed control and establishment of new plantings. Once they are properly staked, ECBs may be cut to allow installation of plants through the fabric.

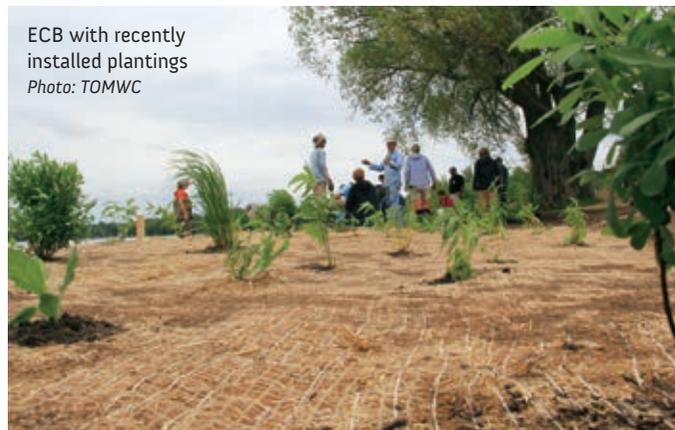
ECB with recently installed plantings
Photo: TOMWC

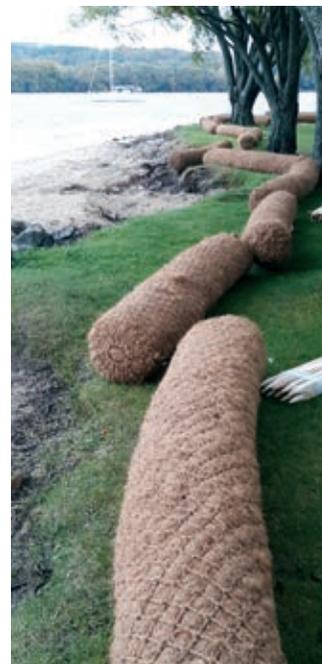
Coir logs staged along shoreline prior to installation.
Photo: J. Buchanan

Biodegradable coir (coconut fiber) logs are held together with other biodegradable materials such as jute twine, and come in a variety of lengths, sizes, and densities. They are used in many applications, most often at the toe of the shoreline, to provide stabilization and promote the development of vegetation. Coir logs provide long-term, yet temporary, protection. As plant roots grow into and through the logs they biodegrade yielding a more resilient shoreline. When conditions allow, plantings can be installed directly into the coir logs, but extra care is then needed to ensure their survivability.

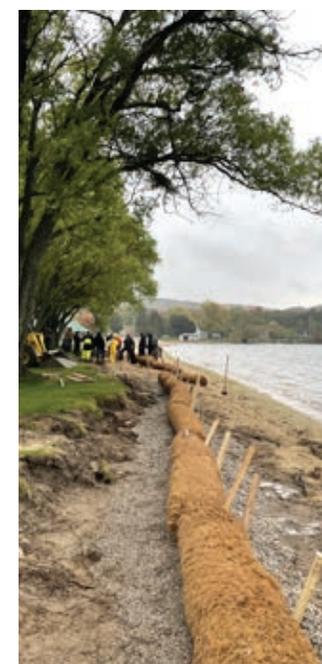
Positioning coir logs before finalizing installation.
Photo: J. Kirkwood

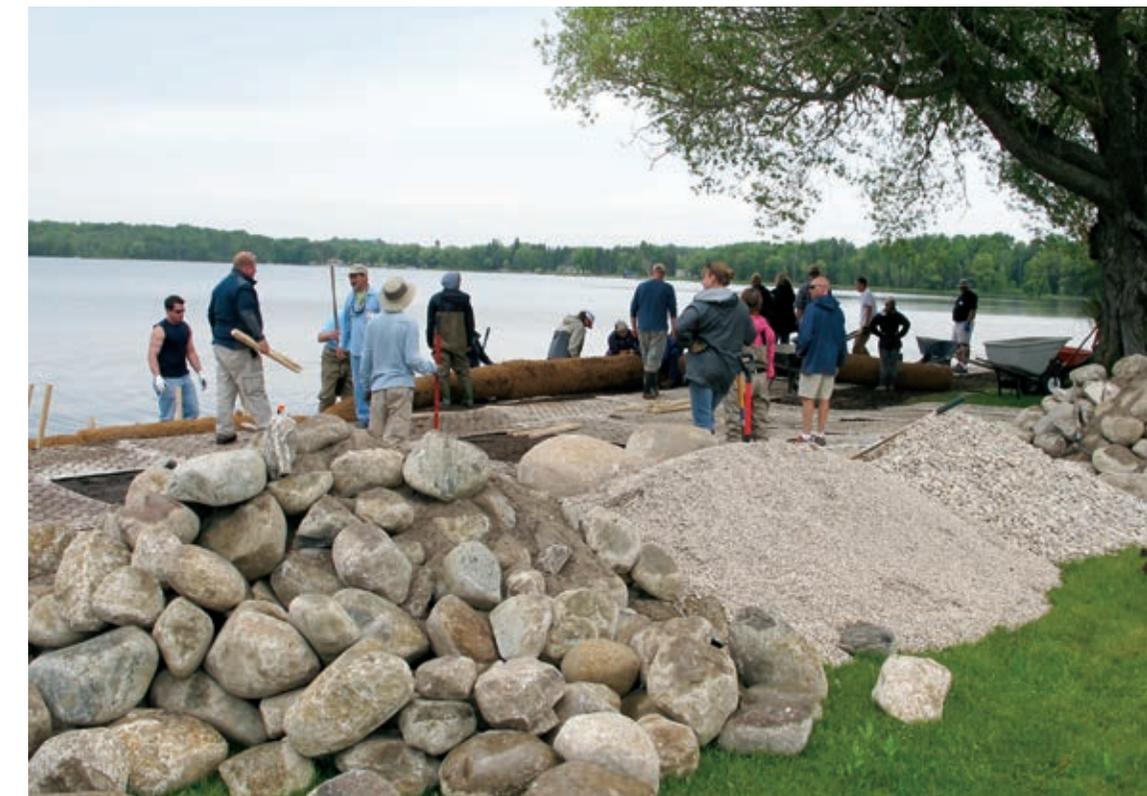
Fieldstone, drain stone, and pea gravel staged prior to installation on a high energy lake.
Photo: J. Buchanan

Many bioengineering projects require the use of rock to help provide stability and resiliency against erosive forces. Whether to use rock or not depends on the site conditions. Rounded fieldstone is recommended over other types of rock, such as angular quarried rock, because it creates a more flexible and resilient system. A mixture of rock sizes is required and the size is determined by the wave height and design. The different sizes of rock act like ball bearings to allow the rock to flex and settle more easily.

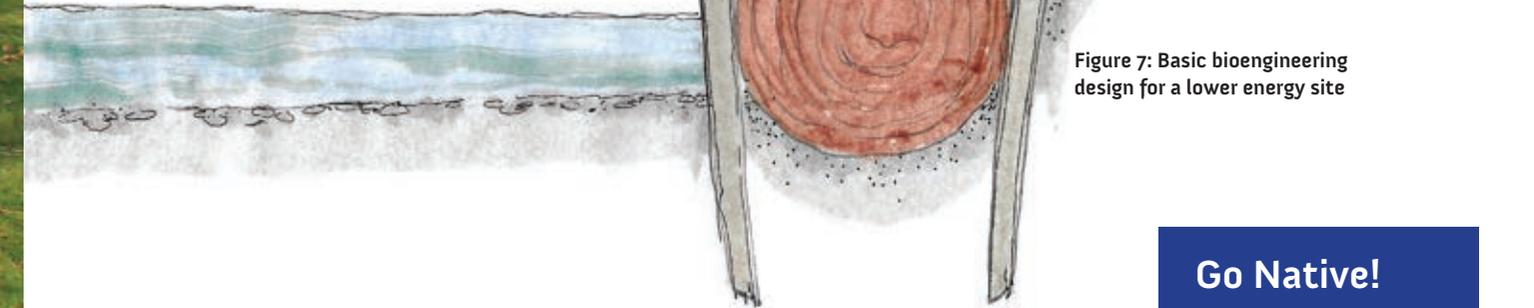
A basic bioengineering design includes coir logs and native plants (See Figure 7). The coir log provides toe protection to allow the plant root systems to become re-established. There may be a need for a minimal amount of rock, such as to provide protection against wave flanking from a neighboring property.

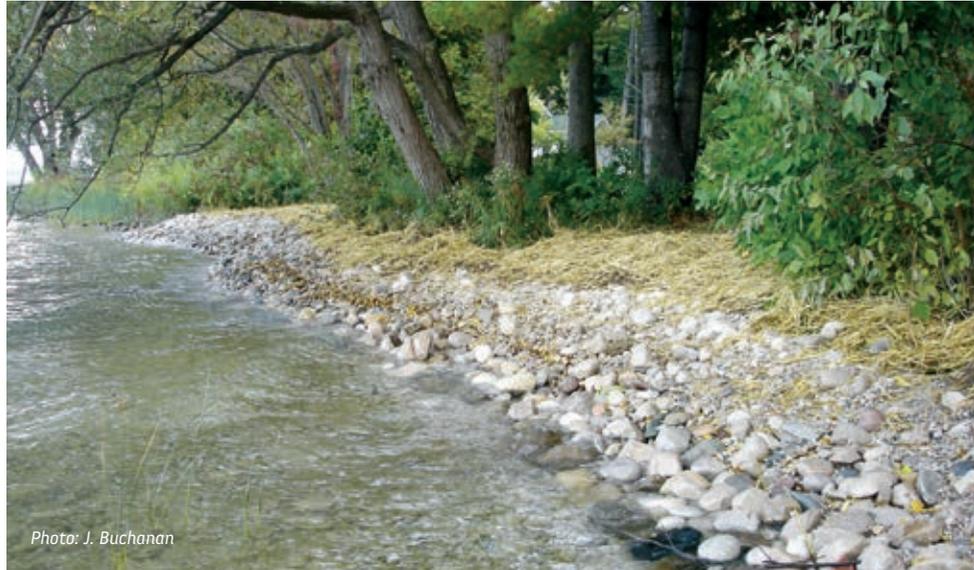
Figure 8: A bioengineering design for a higher energy site.

A bioengineered fieldstone revetment, also called rip rap (See Figure 8), is different from the traditional use of rip rap. This design uses plants, typically a coir log at the bank toe, and three layers of rock: armoring layer, base apron and filter layer. The rock must be sized correctly based on site conditions and installed at an appropriate slope in order to function correctly. The goal is for sand, silt and organic matter to fill in the spaces to help rebuild the shoreline. (See the Importance of Slope on page 19)

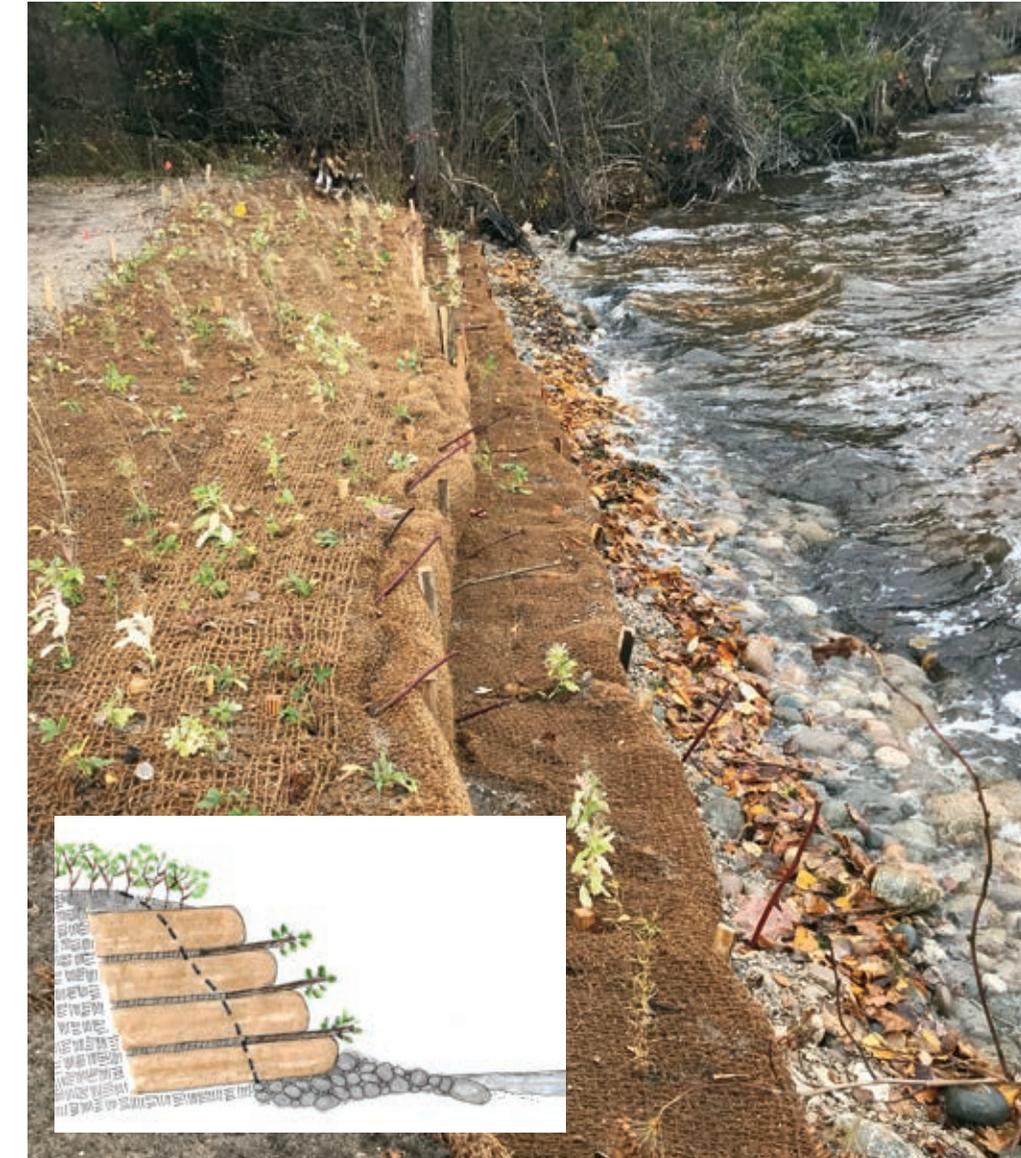
Figure 9: An encapsulated soil lift design and installation.
Photo: TOMWC

Encapsulated soil lifts, sometimes called vegetated geogrids, are layers of soil “encapsulated” inside biodegradable fabric to form the lift and are built on a rock base (See Figure 9). The rock base is sized and sloped correctly per site conditions. Each lift (or layer) is placed on top of the preceding lift, but stepped back to create the desired slope. They are then planted with native plants. Banks typically need to be pulled back to create the desired slope.

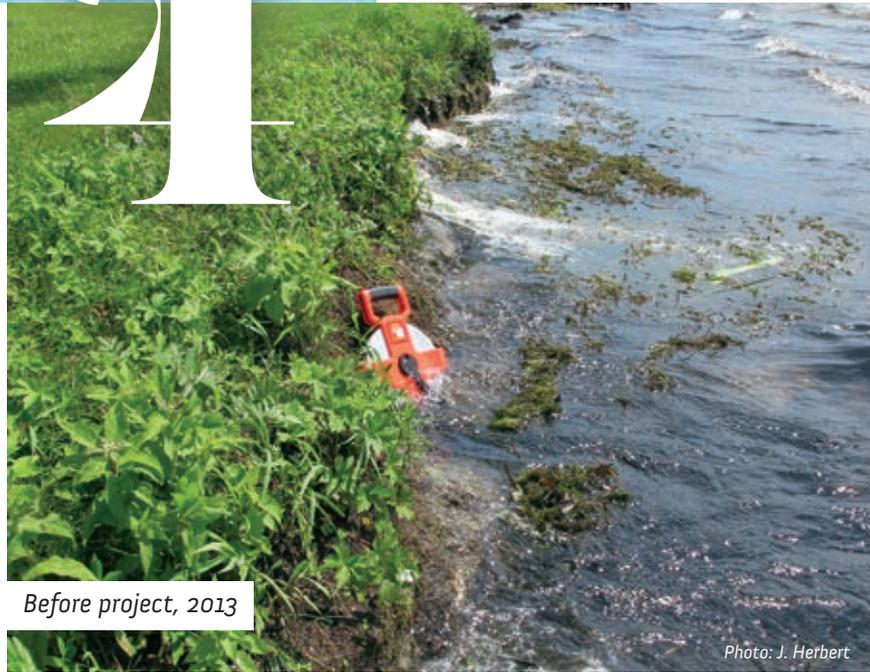
This site had a lack of dense root structure. The bank was actively being undercut and would eventually slump. Based on the site assessment a rock revetment was decided. The bank was not pulled back to avoid disturbing remaining root structure. Gravel and the coir log were tucked into the bank cavity to help provide stability. In addition, 5 yards of sand and 5 yards of topsoil were used in this design.

Before project, 2013

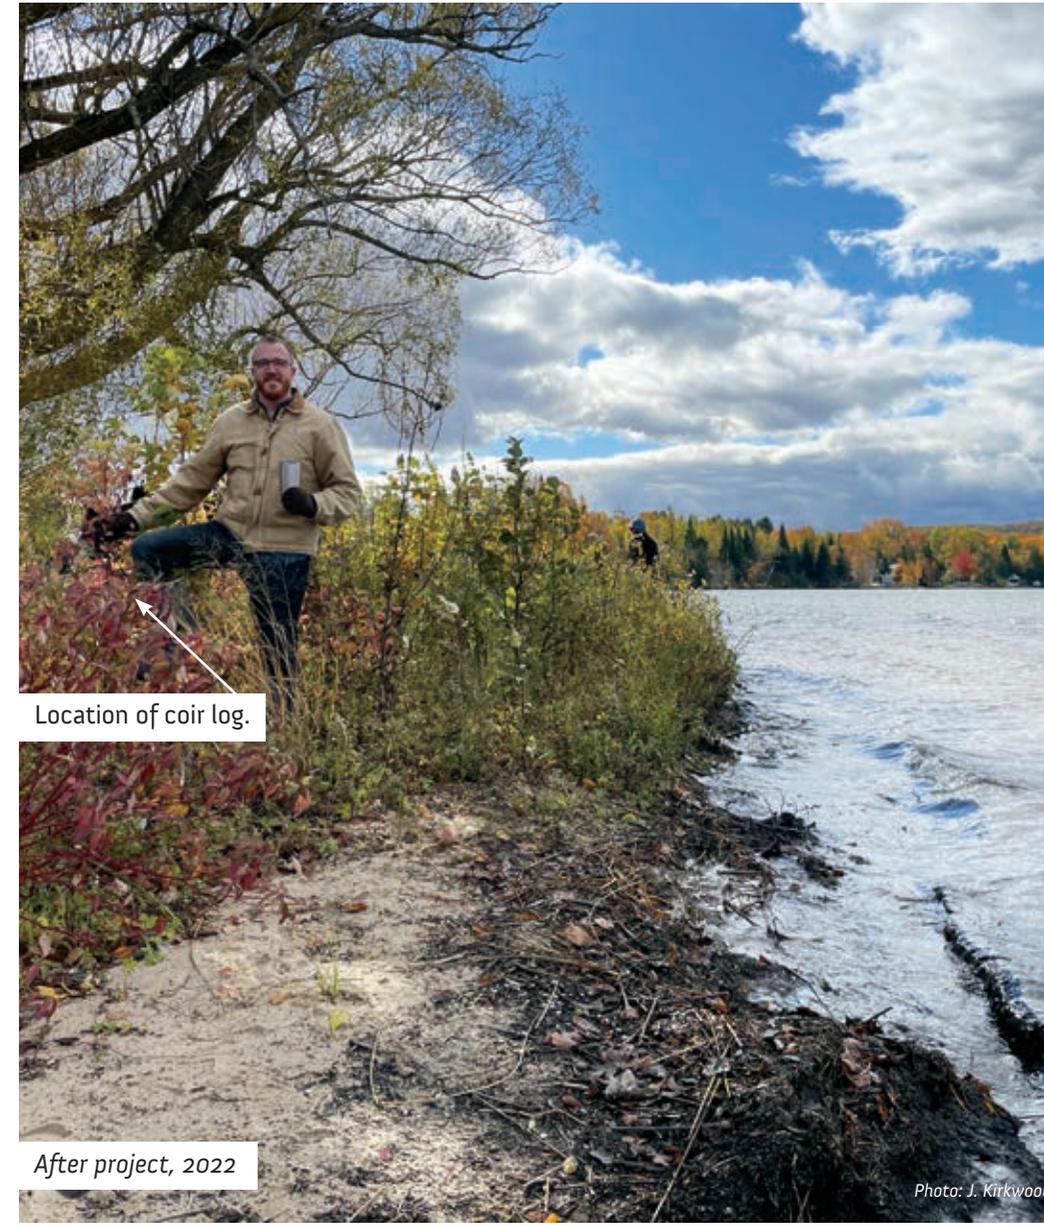
Location of coir log.

After project, 2022

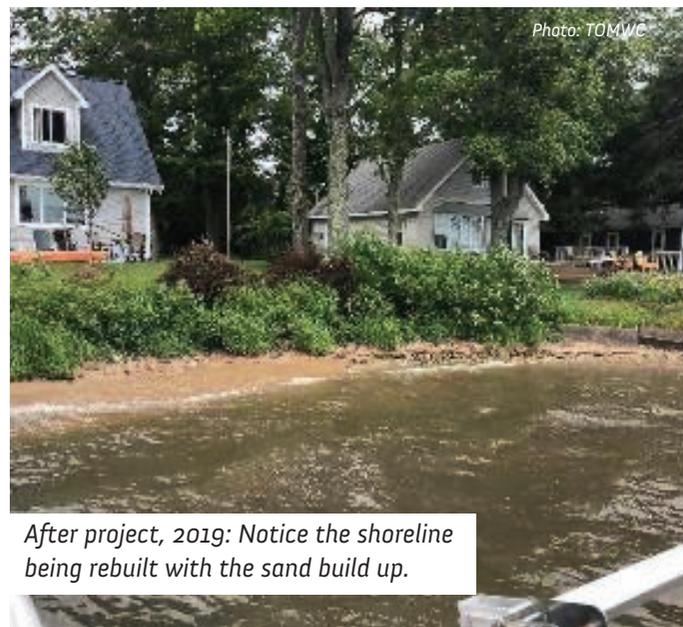
After project, 2019: Notice the shoreline being rebuilt with the sand build up.

This site is at a public park. Erosion was due to frequent boat traffic exacerbated by a nearby boat ramp along with diminished native vegetation. The site assessment also determined that during certain storm events the waves originated from a different direction and were larger than what was typically observed. The design included utilizing the dead ash trees harvested from the site to create woody habitat and a revetment to help abate the boat and storm generated waves. Heavy equipment was not an option at this site due to the sensitivity of the shoreline and limited access.

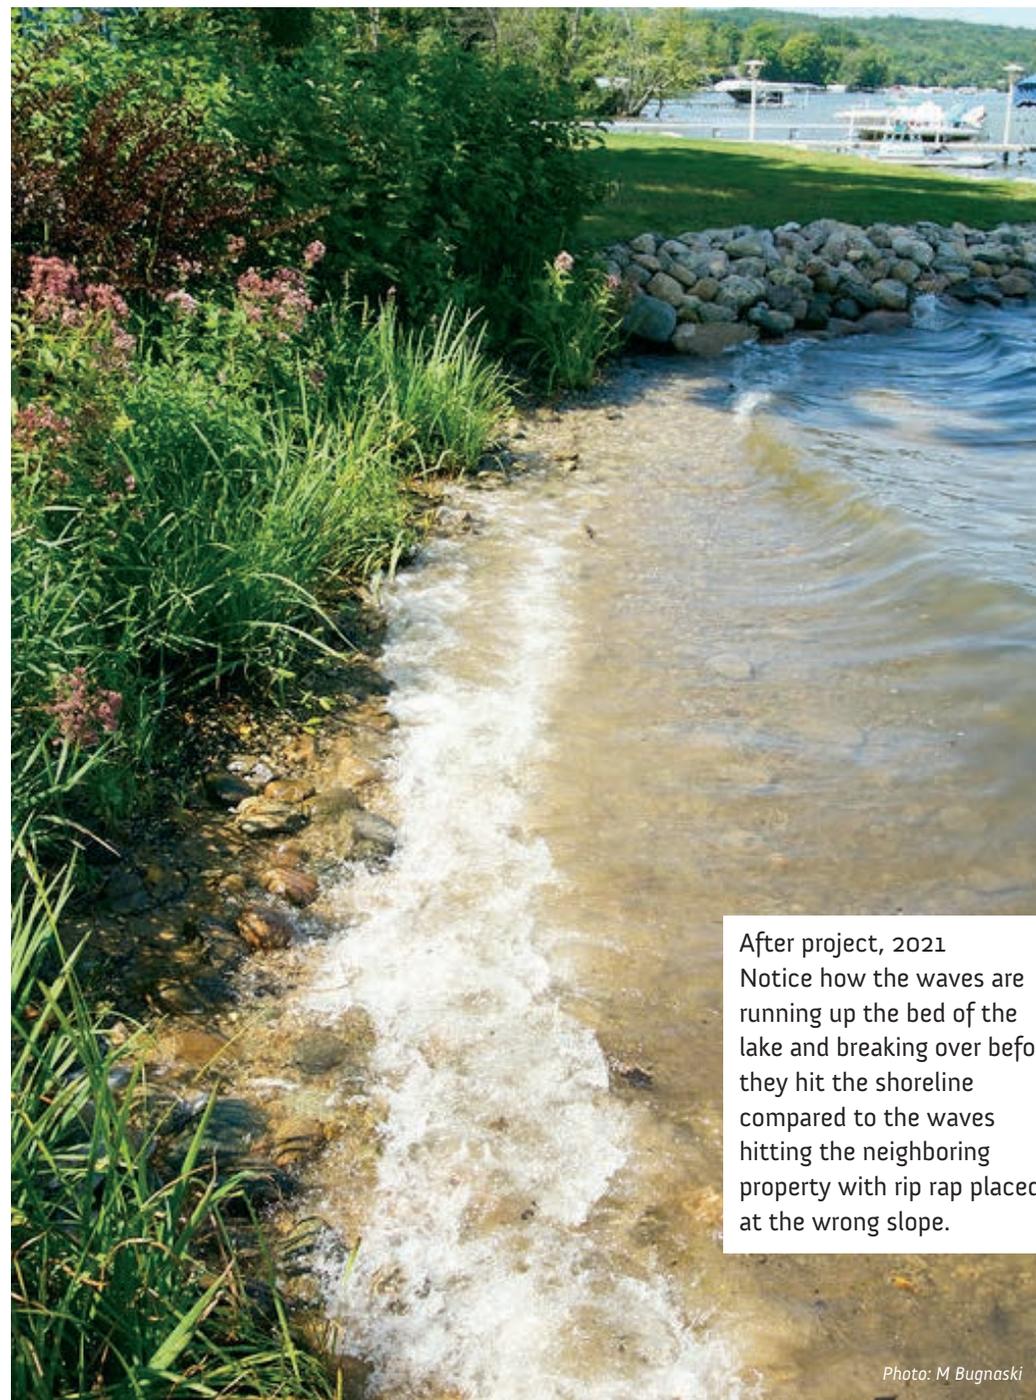
After project, 2021
Notice how the waves are running up the bed of the lake and breaking over before they hit the shoreline compared to the waves hitting the neighboring property with rip rap placed at the wrong slope.

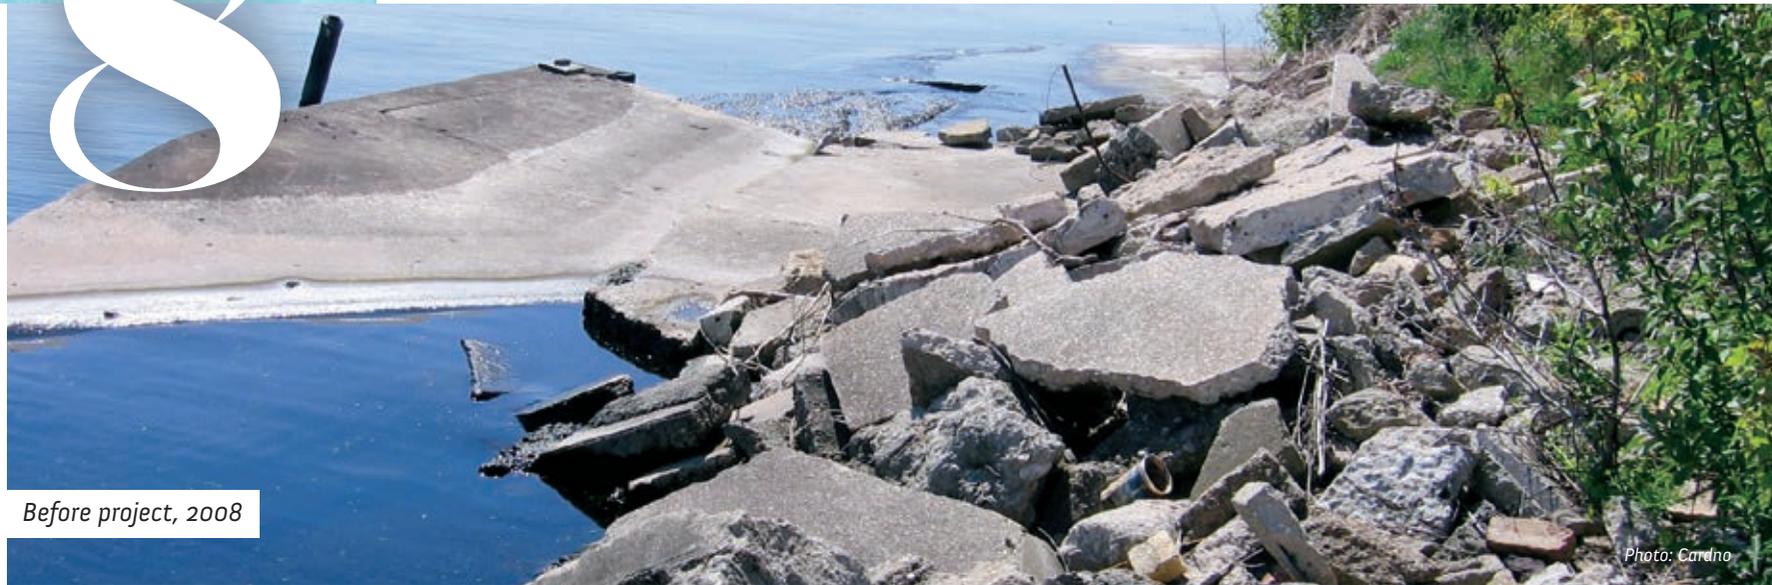
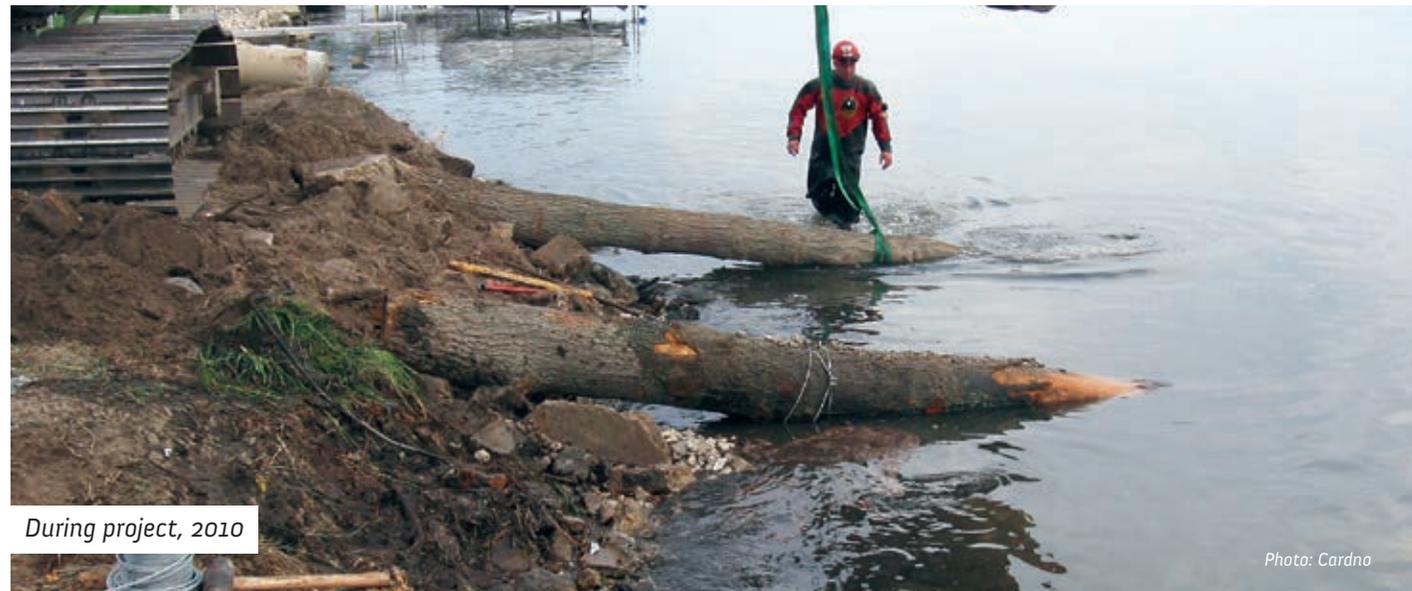
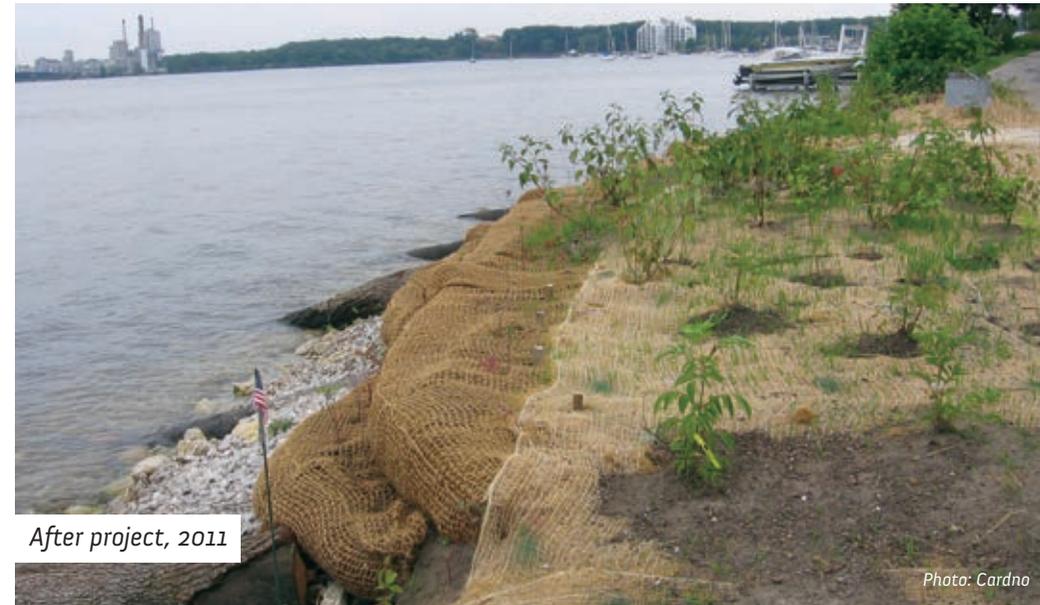
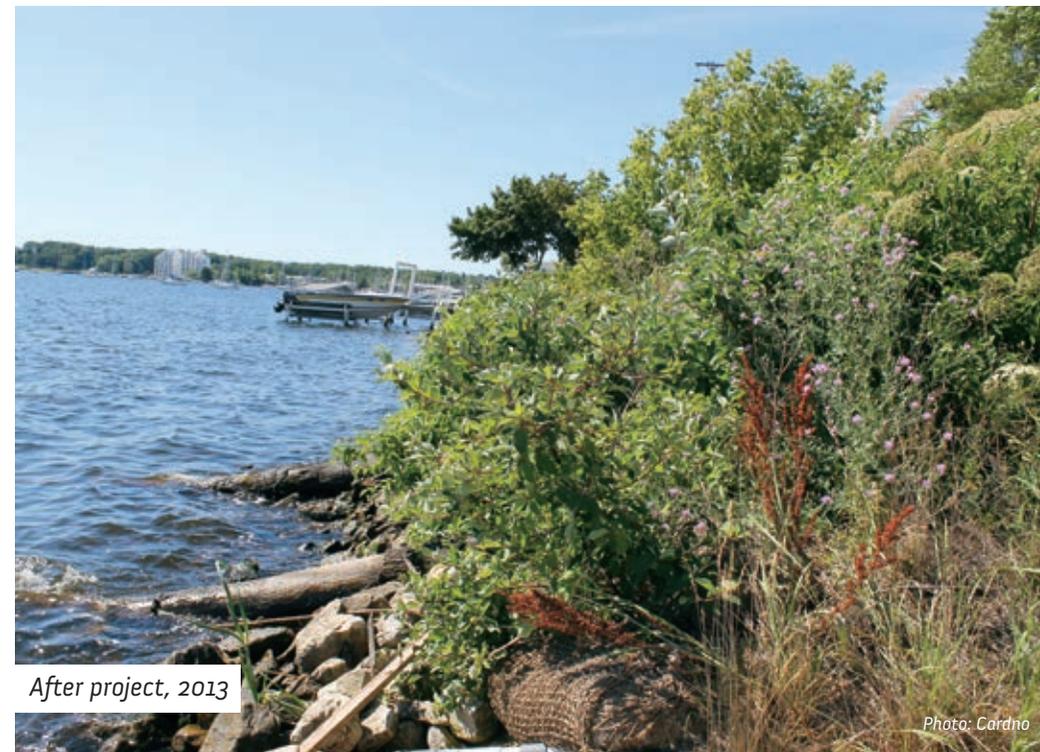
SITE 8

TECHNIQUES: Greenbelt/Buffer; Encapsulated soil lifts; Fieldstone and Tree Revetment

This site is located in a very developed area, with infrastructure close to the lake, and a lot of boat traffic including industrial shipping. The site assessment showed the need to remove the concrete slabs which were historical attempts at erosion control before restoration techniques could be installed. In addition, ice and waves were both a significant problem. Ice sheets up to 3' thick and 8' waves have been observed at this site.

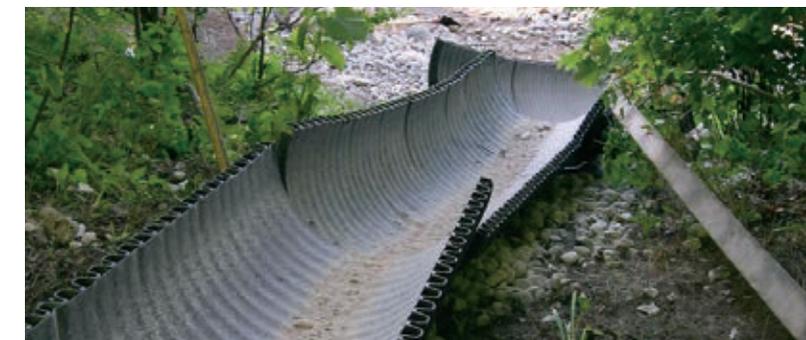
Photo depicting a rock chute to transport rocks to reduce impact.
Photo: J. Buchanan

Accessing lakeshore sites can be challenging for contractors and oftentimes access is limited. As a result, contractors may have to access the shoreline via a barge or use wheelbarrows to transport materials to the shoreline. These factors will impact the cost of the project. Regardless, it is important to consider how to best access the shoreline while minimally impacting the adjoining shoreland/landscape. Shoreline properties are oftentimes low-lying wetland areas that are sensitive to soil compaction from heavy equipment. In this case, devising strategic means to access the shoreline is important. Using wheelbarrows, chutes, and other methods to transport materials to minimize destruction of sensitive plant communities, avoid soil compaction, and reduce risk to septic systems and other utilities is critical. These factors must be weighed beforehand to be sure no further harm is done to the shoreline, the adjoining landscape, and other infrastructure.
